CSI: Münchingen

Something is wrong with the coating in a vehicle component. What happened? A case for the Wörwag test laboratory. Chief investigator Gabriele Roth and her team go looking for clues.

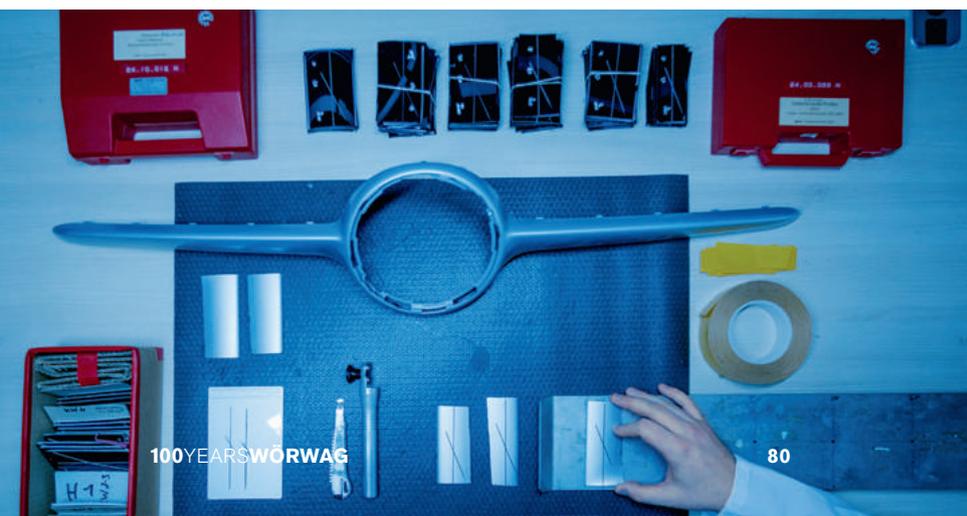
Corpus delicti: the silver-gray decorative element of a radiator grille is prepared for analysis.

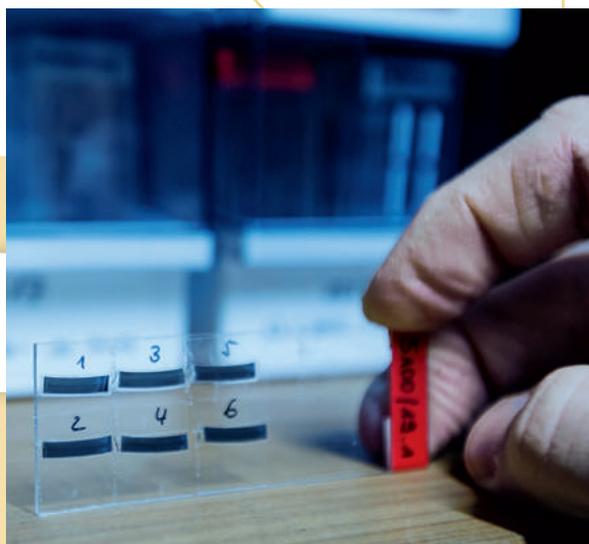
Precision work: for the microscopy, sample slivers 30 micrometers thick are affixed to a slide.

tures. He also determines their thickness. The bottom layer is the substrate, the coated material, in this case the plastic PP/EPDM. On top of this the coating sequence of primer (15 micrometers), base coat (22 micrometers) and clear coat (35 micrometers). "We can clearly see a delamination between the substrate and the primer," he states. In other words, the primer is peeling away from the workpiece.

Why? Zelfi takes a closer look at the surface of the substrate. "Classic pretreatment error. For the primer to adhere optimally to PP/EPDM, it is treated with a

gas flame before being coated. And multiple parameters must be complied with." The flame treatment causes oxygen radicals to be deposited on the surface, changing its polarity and enabling the coating to adhere better. "If the flaming is done at the wrong temperature, too quickly, or with an incorrect mixture, the adhesion does not work." Conclusion: the supplier must check its processes.

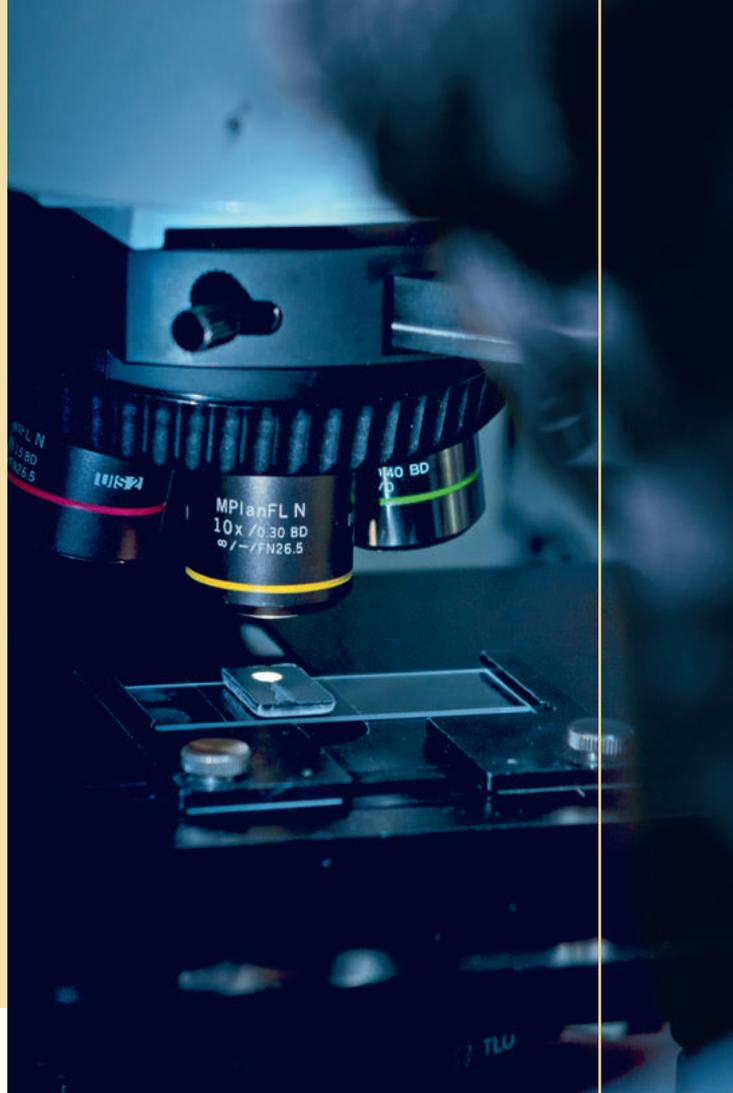
The examination of the surface confirms the suspicion.

Magnification: Roth's team looks at the paintwork as seen through the microscope.
