CSI: Münchingen

Something is wrong with the coating in a vehicle component. What happened? A case for the Wörwag test laboratory. Chief investigator Gabriele Roth and her team go looking for clues.

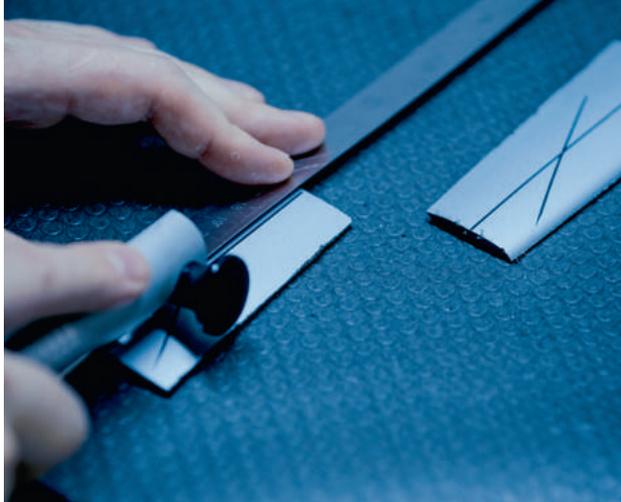
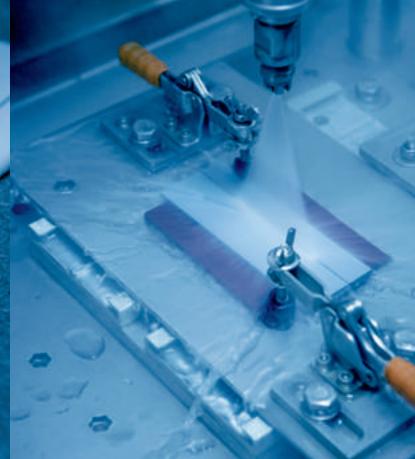
Two doors away she enters room 1.02. The pressurized water test is performed here. There are three cabins to choose from. Mühlich opens the door of the first one and clamps the sample between two brackets. From the prescribed distance she aims the water jet at the middle of the test object. Close door, water on. The 60-degree jet of warm water hits one of the two cuts. "Let's see how the individual layers react." Mühlich has a suspicion but is keeping it to herself for now. Time for a review.

Left image: Zelfl uses a special tool to cut the material sample prior to the pressurized water test (right).

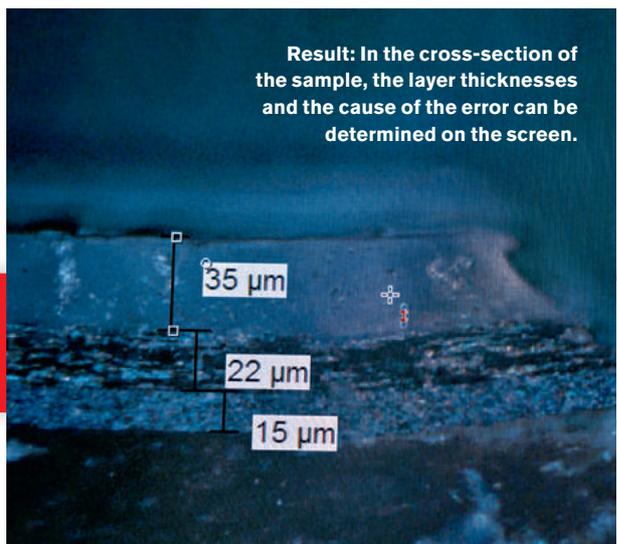
tures. He also determines their thickness. The bottom layer is the substrate, the coated material, in this case the plastic PP/EPDM. On top of this the coating sequence of primer (15 micrometers), base coat (22 micrometers) and clear coat (35 micrometers). "We can clearly see a delamination between the substrate and the primer," he states. In other words, the primer is peeling away from the workpiece.

Why? Zelfi takes a closer look at the surface of the substrate. "Classic pretreatment error. For the primer to adhere optimally to PP/EPDM, it is treated with a

gas flame before being coated. And multiple parameters must be complied with." The flame treatment causes oxygen radicals to be deposited on the surface, changing its polarity and enabling the coating to adhere better. "If the flaming is done at the wrong temperature, too quickly, or with an incorrect mixture, the adhesion does not work." Conclusion: the supplier must check its processes.
